### MOLD INSPECTION AND TESTING REPORT CIRS PROTOCOL

CLIENT	John Bluecheese
PROPERTY ADDRESS	2523 Laboratory Dr ~ Suspect, Colorado 80555
DATE OF INSPECTION	Tuesday, October 13, 2021

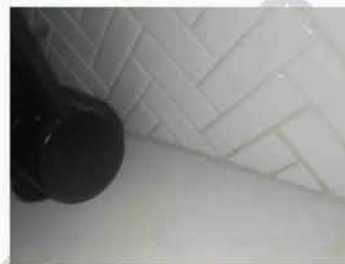
**KITCHEN [NORTH]**

Caulking around toilet and/or sink is in poor condition.

Moisture Content: Dry  
Humidity this area: 56%  
Humidity Outdoor: 65%  
Area Affected: 2 Lineal Ft  
Suspected source(s)/cause(s):  
Cracked / deteriorated caulking

*Cracked and deteriorated caulking observed around sink.*

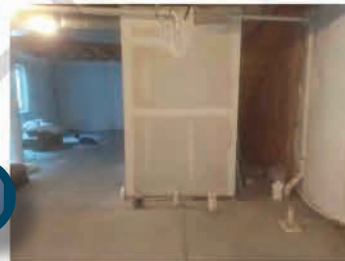
**BASEMENT [WEST]**

Water damage - Moisture staining observed in this

Moisture Content: Dry  
Humidity this area: 47%  
Humidity Outdoor: 65%

*Water staining and damage observed on drywall and sill plate common Utility Closet.*

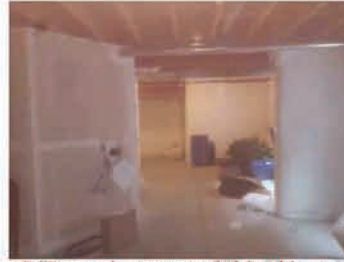
**LOWER LEVEL [EAST]**

qPCR sample recommended for this area.

*qPCR sample recommended for this area.*

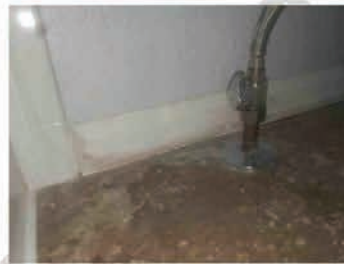
**HALL BATHROOM [EAST]**

Water damage - Moisture damage or staining observed in this area.

Moisture Content: Dry  
Humidity this area: 46%  
Humidity Outdoor: 65%  
Area Affected: 3 Lineal Ft  
Suspected source(s)/cause(s):  
Incidental moisture from shower and/or previous toilet plumbing leak and/or previous Laundry Room plumbing leak

*Water staining and damage observed on baseboards around shower and toilet plumbing.*

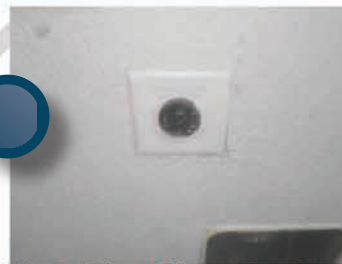
**LAUNDRY ROOM [EAST]**

Water damage - Moisture damage or staining observed in this area.

Area Affected: 8 x 2 Ft

Suspected source(s)/cause(s):  
Previous roof leak and/or previous laundry plumbing leak and/or previous Hall Bathroom plumbing leak

*Water staining and damage observed on ceiling and wall common Hall Bathroom.*

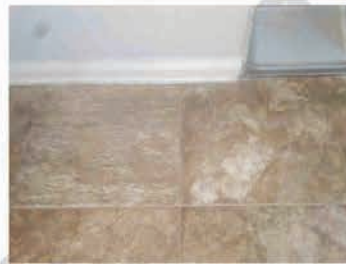
**LAUNDRY ROOM [EAST]**

Water damage - Moisture damage or staining observed in this area.

*Water staining and damage observed on baseboard and flooring.*

Area Affected: 3 Sq Ft

Suspected source(s)/cause(s):  
Previous roof leak and/or previous laundry plumbing leak and/or previous Hall Bathroom plumbing leak

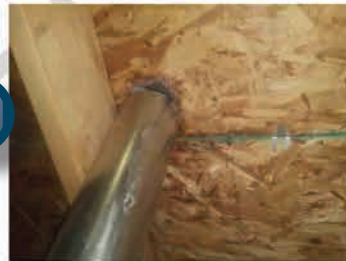
**ATTIC [WEST]**

Water damage - Moisture damage or staining observed in this area.

Area Affected: 8 Sq Ft

Suspected source(s)/cause(s):  
Previous leak at roof

\* Humidity level for this area is above the ASHRAE recommended level for habitable spaces. Preferable level is between 30% and 60%.

*Water staining and damage observed on sheathing around Hall Bathroom vent termination.*

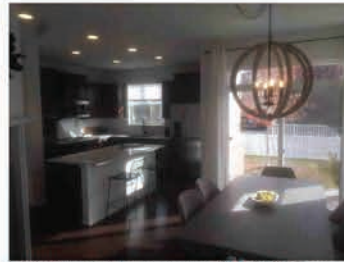
**MAIN LEVEL [EAST]**

qPCR sample recommended for this area.

*qPCR sample recommended for this area.  
Suspect area: Kitchen.*
