MOLD INSPECTION AND TESTING REPORT MOLD RELATED ILLNESS & CIRS PROGRAM

CLIENT	John Smith
PROPERTY ADDRESS	123 Sample St ~ Anytown, CA 98765
DATE OF INSPECTION	Friday, May 30, 2025

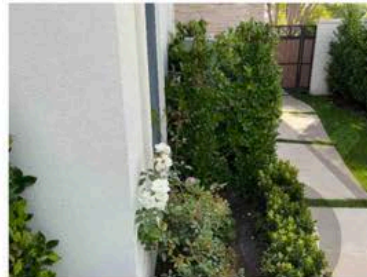
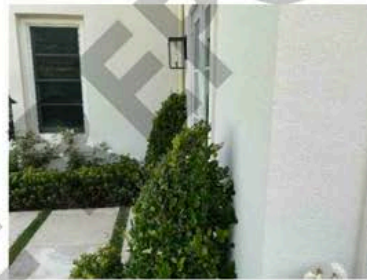
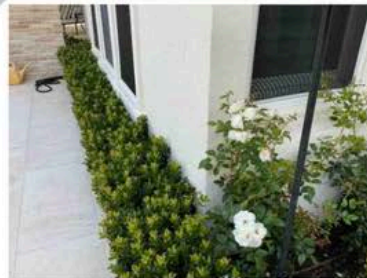
Plants/trees are coming into contact with the roof/walls.

Suspected
source(s)/cause(s):
**Vegetation in contact with
exterior walls**

*Observed bushes in contact with the
exterior walls around the property.*

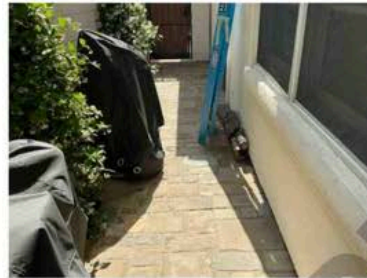
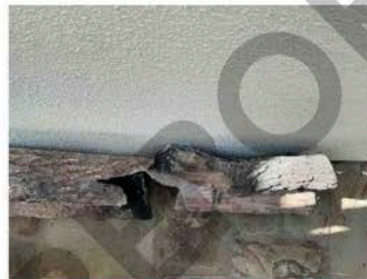
EXTERIOR [SOUTH]

Firewood is stacked against the structure.

Observed some firewood against the South exterior walls.

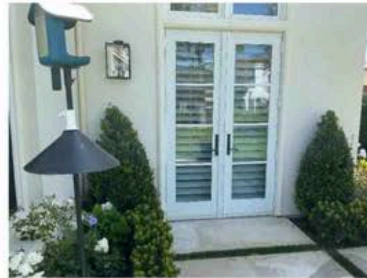
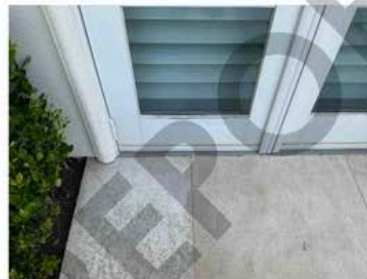
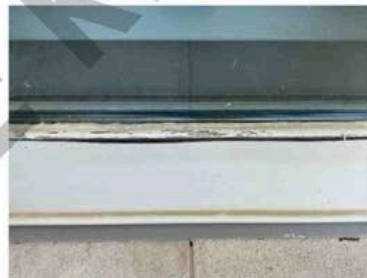
EXTERIOR [SOUTHEAST]

Caulking / Grout was observed in poor condition.

Suspected
source(s)/cause(s):
**Previous exterior moisture
intrusion**

*Observed some deteriorated caulking
on this French door adjacent to the
Formal Dining Room. Also observed
some water damage to the door.*

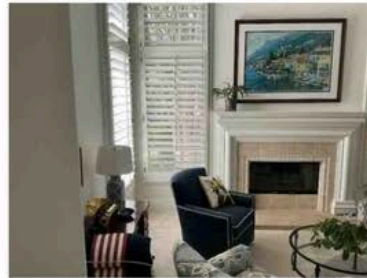
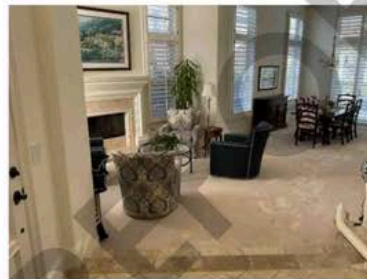
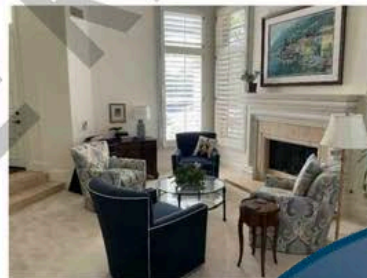
Area photos of formal living space. The client stated flooded by water loss and

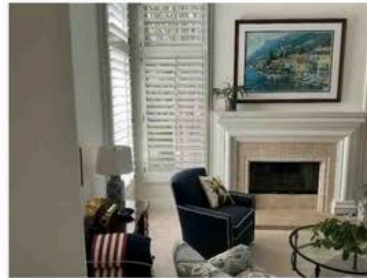
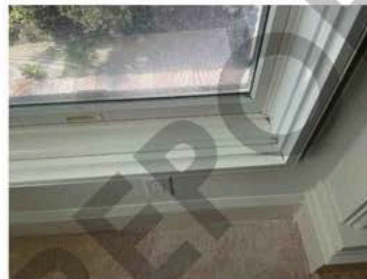
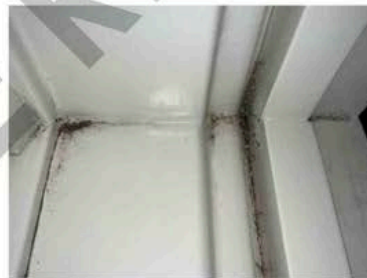
**FORMAL LIVING ROOM
[SOUTHEAST]**

Evidence of mold-like growth was observed.

Suspected
source(s)/cause(s):
**Previous leak at water
supply line / previous
flooding**

*Observed some mold like growth on
the window shutter framing on the
South wall to the left of the chimney.*

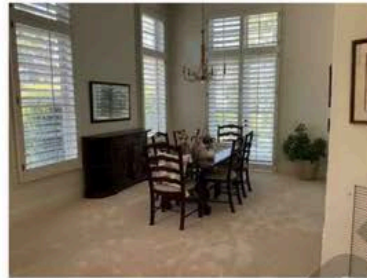
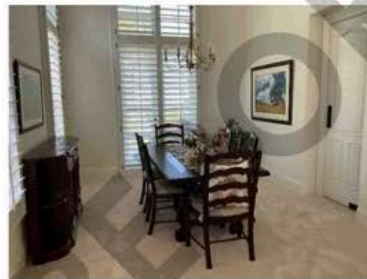
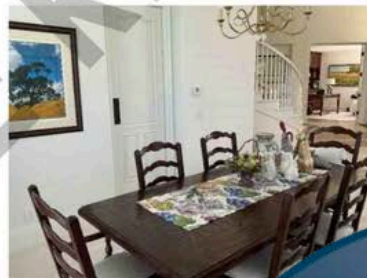
*Area photos of Formal Dining Room.
The area was impacted by a common water loss floor
mitigated.*

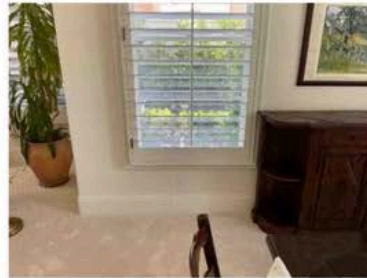
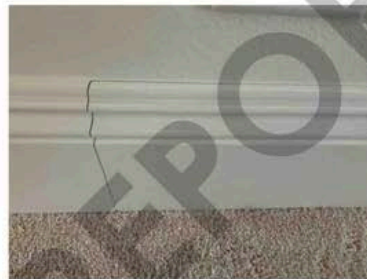
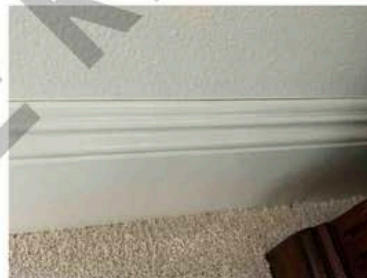
FORMAL DINING ROOM [SOUTH]

Client stated a previous moisture intrusion affected this area.

Suspected
source(s)/cause(s):
**Previous leak at water
supply line**

Observed baseboard separation from wall in this South Formal dining room wall. The client stated that some of these baseboards were reused after water flood mitigation.

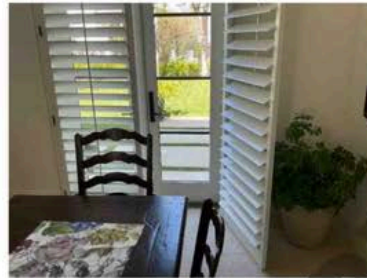
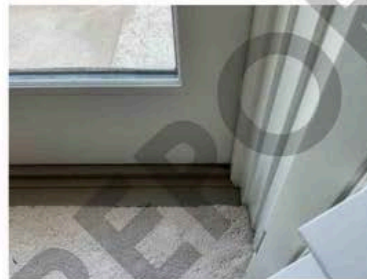
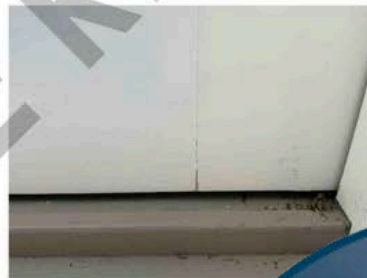
FORMAL DINING ROOM [WEST]

Water damage - Moisture damage or staining observed in this area.

Suspected
source(s)/cause(s):
**Previous exterior moisture
intrusion**

Observed water damaged floor common to the exterior of deteriorating caulking on French door.

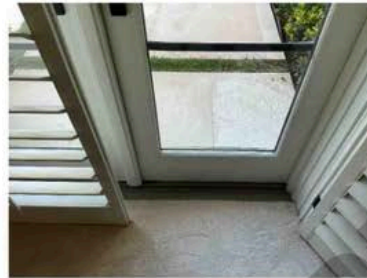
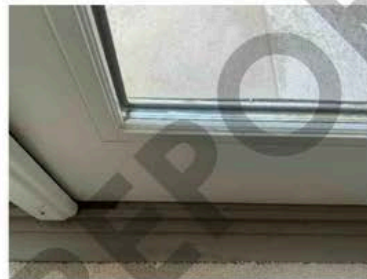
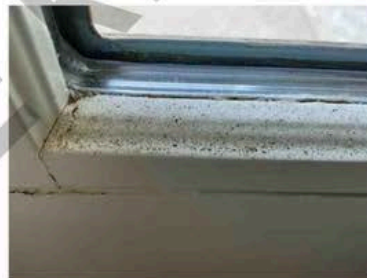
FORMAL DINING ROOM [WEST]

Evidence of mold-like growth was observed.

Suspected
source(s)/cause(s):
Humidity - condensation

Observed some mold-like growth on this window of the right side French door.

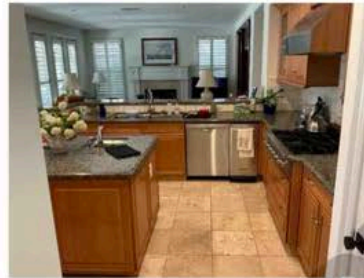
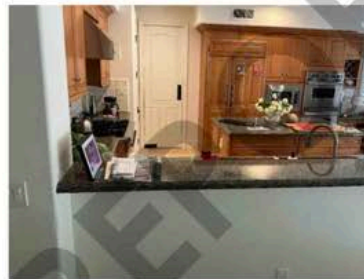
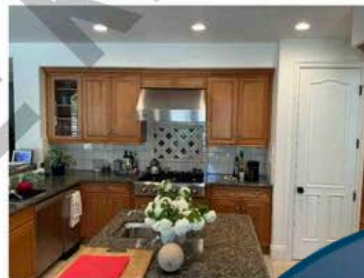
KITCHEN

Humidity this area: 62%
Humidity Outdoor: 60%

* Humidity level for this area is above the ASHRAE recommended level for habitable spaces. Preferable level is between 30% and 60%.

Area photos of Kitchen. The stated in the past that this flooded by a water leak. Primary bathroom also down through kitchen fixtures.

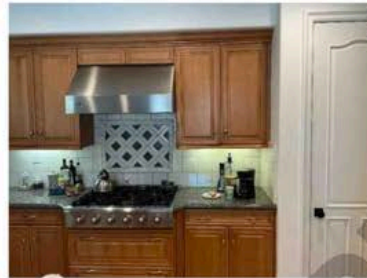
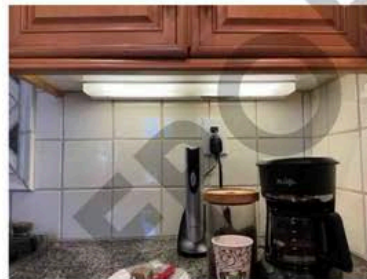
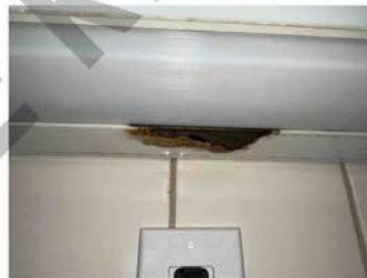
KITCHEN [SOUTHEAST]

Corrosion, rust, and/or leaks were observed.

Observed some rust on this light fixture under top cabinets, East wall. The client stated water was coming down through the vent hood from the common water leak from upstairs Primary Bathroom.

Suspected source(s)/cause(s):
Previous leaks and-or spills

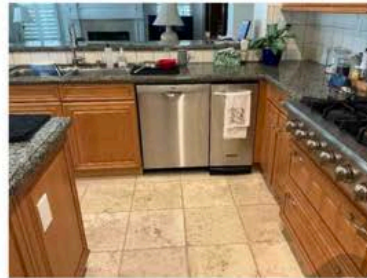
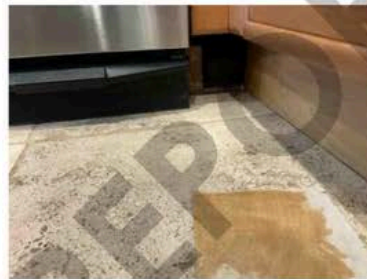
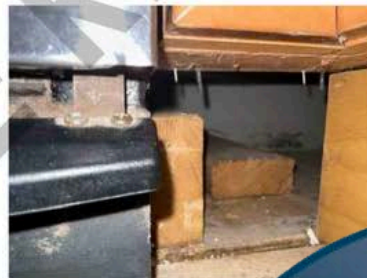
KITCHEN [NORTHEAST]

Evidence of mold-like growth was observed.

Observed mold like growth in cabinetry where the sink/dishwasher is located.

Suspected source(s)/cause(s):
Previous humidity - condensation / Previous leaks

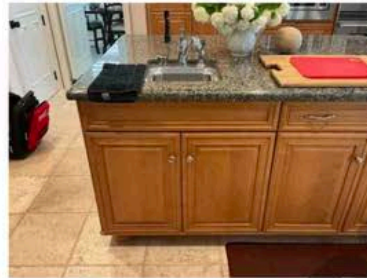
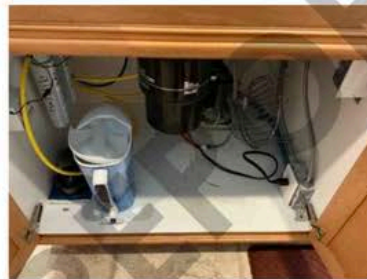
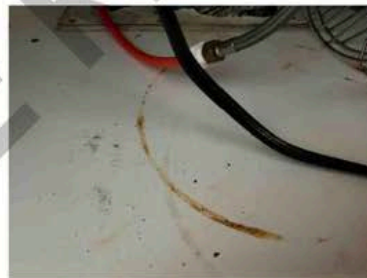
KITCHEN [SOUTH]

Water damage - Moisture damage or staining observed in this area.

Observed some staining under the kitchen sink at the island.

Suspected
source(s)/cause(s):
**Previous sink plumbing
leaks and-or spills**

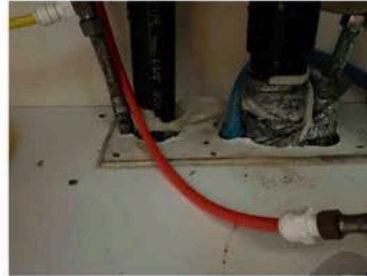
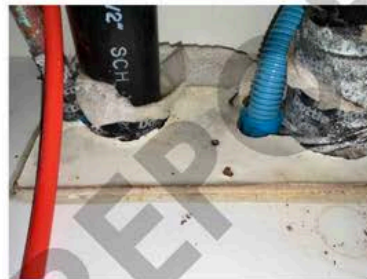
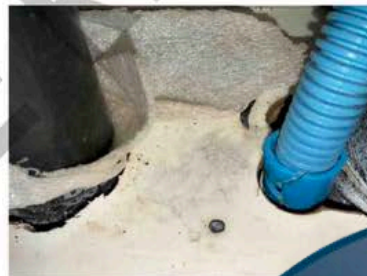
KITCHEN

Evidence of mold-like growth was observed.

Observed mold-like growth island sink between drain

Suspected source(s)/cause(s):
Humidity - condensation

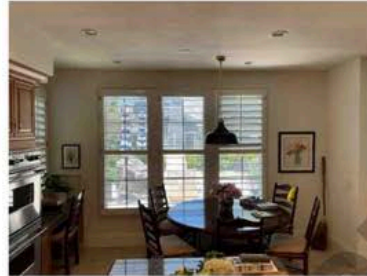
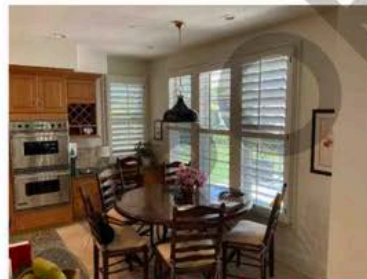
DINING AREA

Humidity this area: 62%
Humidity Outdoor: 60%

Area photos of the dining area near the kitchen. The client stated and showed me a video of water running down the recessed light fixtures from a cold water line leak from under a vanity in the Primary Bathroom.

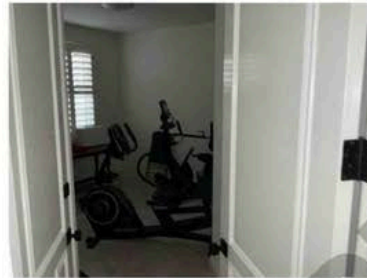
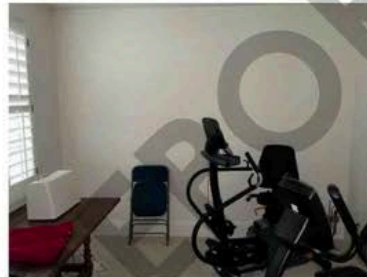
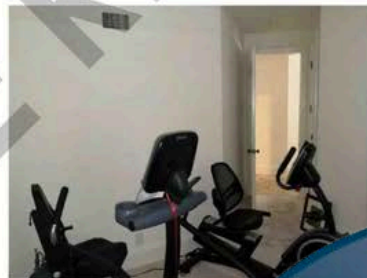
Area photos of the NE bedroom showing previous common flooding in this room and shared room space.
