MOLD INSPECTION AND TESTING REPORT

CLIENT	Sample Client
PROPERTY ADDRESS	1234 Mold Inspection Lane
DATE OF INSPECTION	Thursday, May 17, 2018

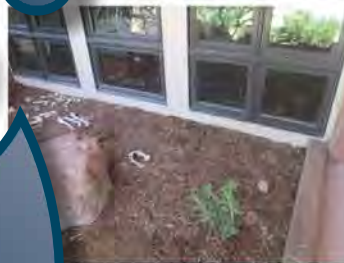
Landscaping materials are in contact with the stucco wall coverings.

Suspected source(s) of water intrusion:
Vegetation in contact with exterior wall coverings
